**Flood Control Project Maintenance
Levee Inspections**

Fall 2018 Levee Maintenance Deficiency Summary Report

Sacramento River Basin

Reclamation District No. 0537 Lovdal

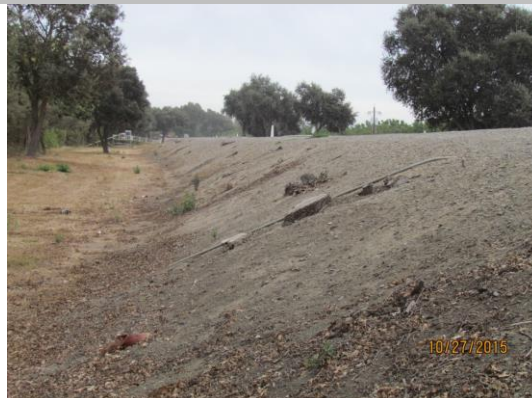
Photo 1 of 1 : FA_2018_RD0537_173_22_20180904_00016.jpg

View of the tree stumps on the waterward side of the levee looking downstream. Fall 2015.

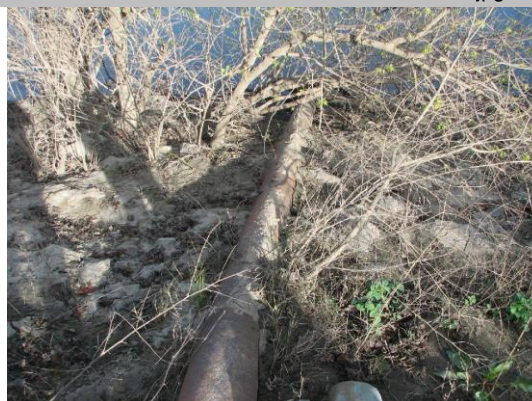
Photo 1 of 3 : UCIP_FA_2018_53398_17141.jpg

WS- abandoned steel pipe.

UCIP Comments: 07/17/2018 Pipe has severely corroded and silted inside. Needs to be abandoned properly or removed. Recommend internal pipe inspection to determine pipe integrity through levee. (O.Yakimov-DWR UCIP)07/18/2016 - Same as last inspection. Pipe severely corroded. Since it is a deep irrigation pipe, cracking on pavement likely not caused by pipe. (K. Fazel/UCIP)03/18/2013 - Crossing appears abandoned; if so, must be done so properly. Cracking on pavement along pipe alignment. Holes visible on pipe along WS slope. (P. Amatya/UCIP)

FIELD_STRUCT_DESC: *ABANDONED* 10-inch steel irrigation discharge pipe through the levee, 18 feet below the crown. Centrifugal pump on the waterside (WS). Concrete collar on the WS per permit drawing, not found in 2016. Polyvinyl chloride (PVC) standpipe and valve enclosed by a concrete standpipe off the landside (LS) toe, likely not associated with the crossing, per Ken Lang of Reclamation District No. 537 (RD0537). 1-inch electrical conduit through the levee, 3.8 feet below the crown, this may not be associated with the crossing, per Ken Lang. (Plans for the installation of a pumping plant with a 10-inch discharge pipe through the levee authorized under Permit No. 558, 1932 - A. Marty and Brothers). Current adjacent landowner is the Giovenetti Ranch, but the pipe is not used by the landowner. [Additional Reference(s): DWR Levee Log, 2004, referenced as 8.3 feet below the crown]. Permit drawing issued in 1932 indicates that the pipe depth is 6.7 feet; however, permit was issued prior to the construction of a new levee prism above the old levee in 1955.

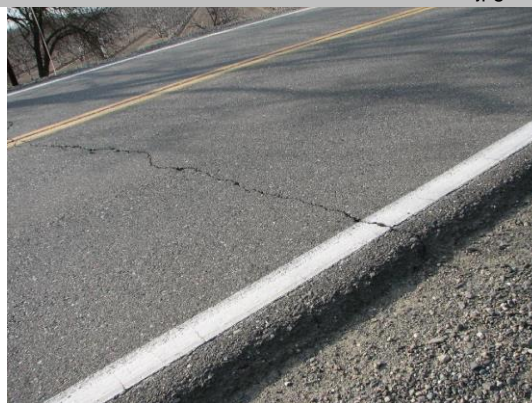
Photo 2 of 3 : UCIP_FA_2018_53398_17146.jpg

Crown- cracked crown pavement.

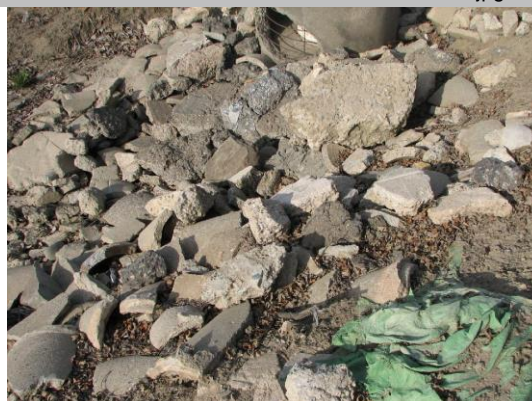
Photo 3 of 3 : UCIP_FA_2018_53398_17147.jpg

LS- pieces of concrete standpipe

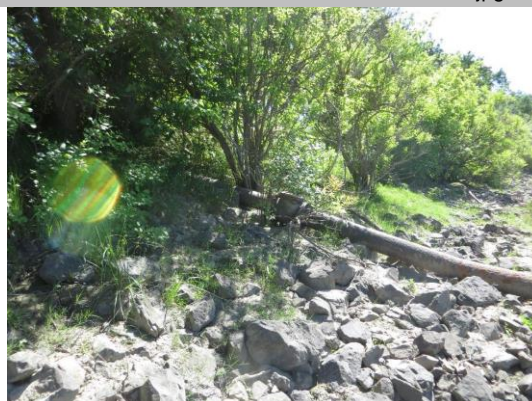
Photo 1 of 3 : UCIP_FA_2018_46803_74402.jpg

Comment Code						
Inspector Comment						
FS_ID:46803 DS_ID:168 EP_NO: N/A Repair Type: Non-Urgent Crossing Status: Found UCIP Comments: Crossing appears abandoned; if so, must be done so properly. FIELD_STRUCT_DESC: *ABANDONED* 10-inch coated steel irrigation discharge pipe, 3.8 feet below the crown. Pump is gone. Concrete pump pad on the waterside (WS) bank, not found. 36-inch concrete standpipe off the landside (LS) toe. 2-inch electrical conduit through the levee, not found. 1-inch electrical conduit found for the 10-inch pipe located 50 feet upstream. Plate bolted to the WS end of the pipe. [Additional Reference(s): DWR Levee Log, 2004]. FS Date: 4/29/2015

Pipe visible along WS slope.

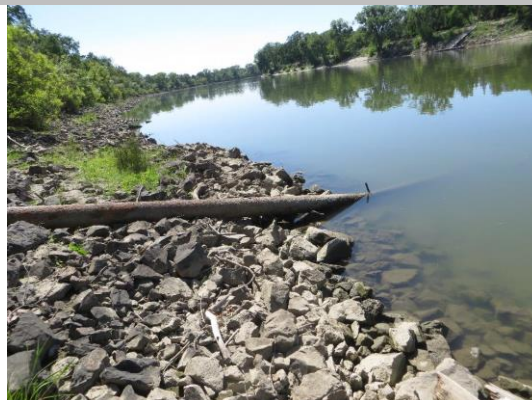
Photo 2 of 3 : UCIP_FA_2018_46803_74403.jpg

View of pipe into water.

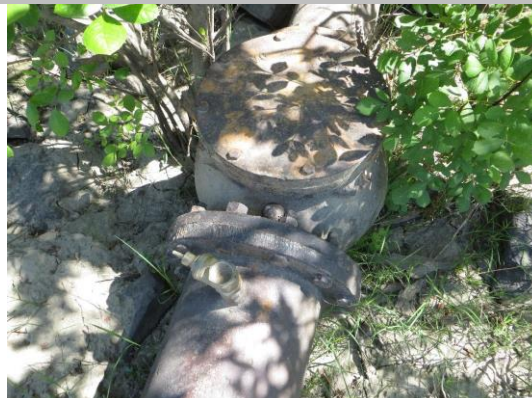
Photo 3 of 3 : UCIP_FA_2018_46803_74404.jpg

Closeup of plates bolted to pipe on WS slope.

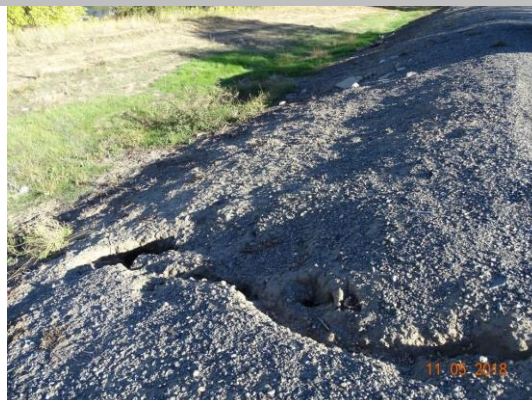
Photo 1 of 1 : FA_2018_RD0537_173_34_20181105_00090.jpg

LM Start	0.18	Rating **	A/W	Issue No.	34
LM End	0.23	Issue Type +	Ma	Location *	WS
Category	Earthen Levee			GPS Latitude/Longitude	
				Start	End
Item	Erosion / Bank Caving			38.644628 °	38.645083 °
				-121.581589 °	-121.580843 °
DWR ID	DWR_RD0537_01_f_2016_34				
Comment Code					
E1 : Note and monitor erosion site.					
Inspector Comment

View of erosion on the waterside slope. Fall 2018.

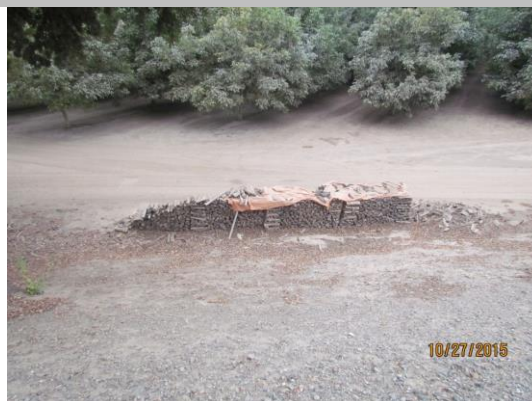
Photo 1 of 3 : FA_2018_RD0537_173_47_20180904_00038.jpg

View of the firewood pile at the toe of the levee on the landward side. Fall 2015.

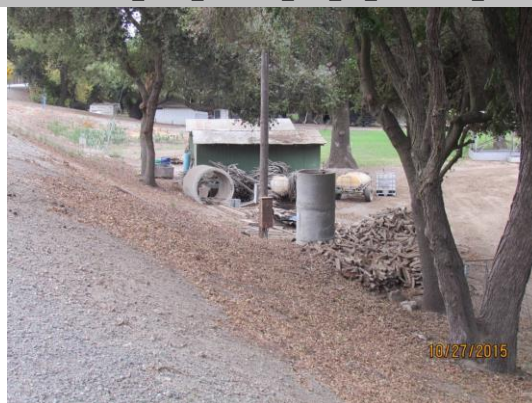
Photo 2 of 3 : FA_2018_RD0537_173_47_20180904_00039.jpg

LM Start	0.38	Rating **	M	Issue No.	47 (cont)
LM End	0.38	Issue Type +	En	Location *	LS

Perspective view of more firewood at the toe of the levee on the landward side looking downstream. Fall 2015.

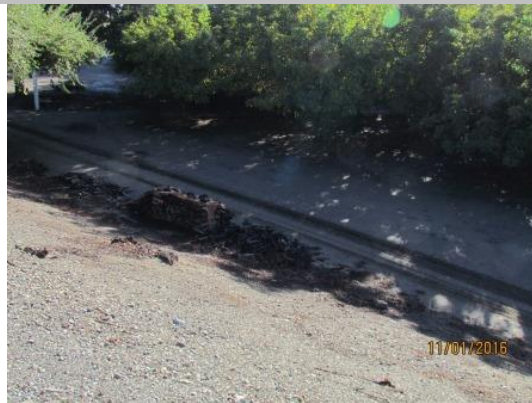
Photo 3 of 3 : FA_2018_RD0537_173_47_20180904_00040.jpg

LM Start	0.38	Rating **	M	Issue No.	47 (cont)
LM End	0.38	Issue Type +	En	Location *	LS

Updated view of firewood at LS toe. Fall 2016.

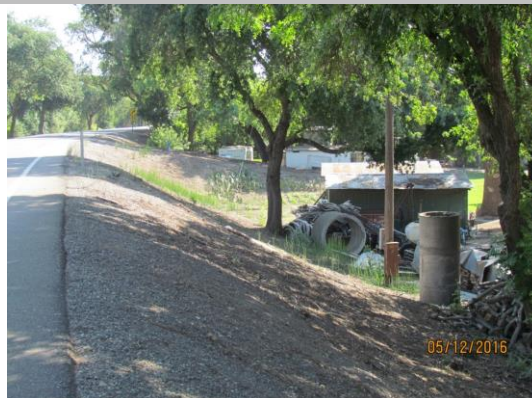
Photo 1 of 2 : FA_2018_RD0537_173_6_20180904_00002.jpg

View of the equipment at the toe of the levee looking downstream. Spring 2016.

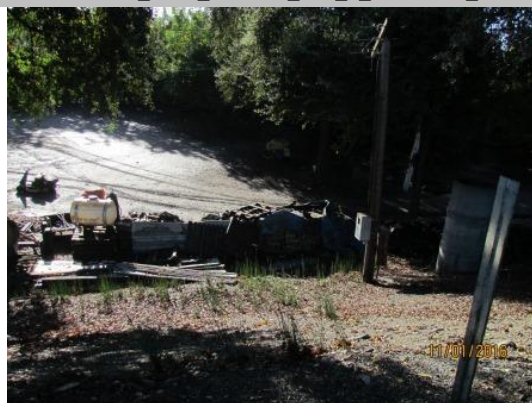
Photo 2 of 2 : FA_2018_RD0537_173_6_20180904_00003.jpg

LM Start	0.39	Rating **	M	Issue No.	6 (cont)
LM End	0.39	Issue Type +	En	Location *	LS

Updated view of equipment at landside toe. Fall 2016.

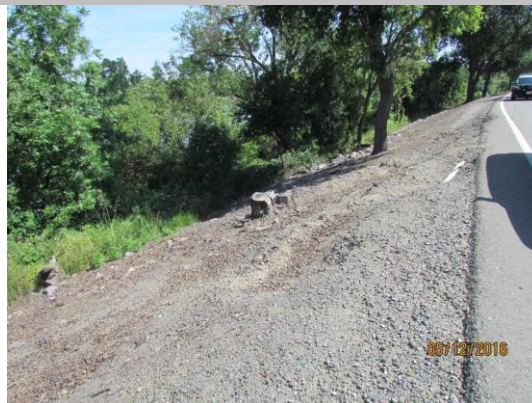
Photo 1 of 1 : FA_2018_RD0537_173_31_20180904_00021.jpg

LM Start	0.42	Rating **	A/W	Issue No.	31
LM End	0.42	Issue Type +	Ma	Location *	WS
Category	Earthen Levee			GPS Latitude/Longitude	
				Start	End
Item	Slope Stability			38.646811°	38.646811°
				-121.578241°	-121.578241°
DWR ID	DWR_RD0537_01_s_2016_31				
Comment Code					
S3 : Repair the levee slope damaged by vehicle traffic and prevent access where possible.					
Inspector Comment

View of the slope stability near the shoulder of the waterwrld side of the levee looking downstream. Spring 2016.

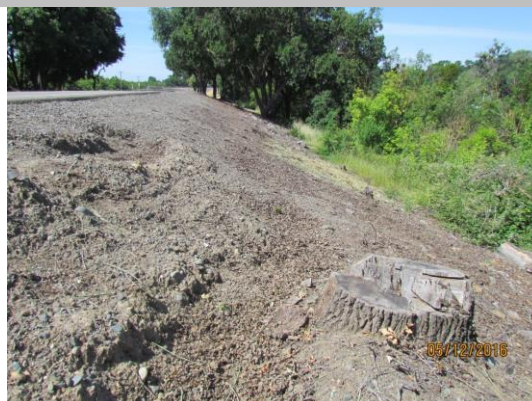
Photo 1 of 1 : FA_2018_RD0537_173_32_20180904_00022.jpg

View of the tree stump on the waterward side of the levee looking downstream. Spring 2016.

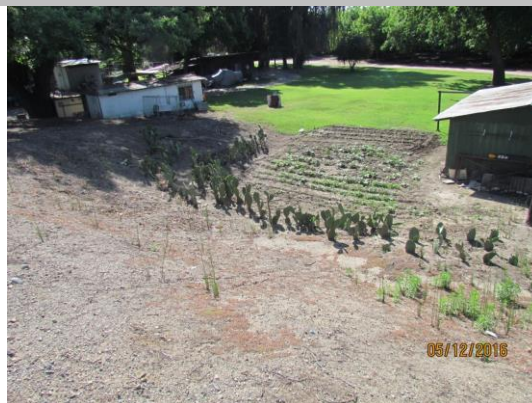
Photo 1 of 2 : FA_2018_RD0537_173_18_20180904_00014.jpg

LM Start	0.42	Rating **	M	Issue No.	18
LM End	0.42	Issue Type +	En	Location *	LS
Category	Earthen Levee			GPS Latitude/Longitude	
				Start	End
Item	Vegetation			38.646803 °	38.646803 °
				-121.578215 °	-121.578215 °
DWR ID	DWR_RD0537_01_s_2018_18				
Comment Code					
V6 : Landscaping					
Inspector Comment

View of the cactus at the toe of the levee. Spring 2016.

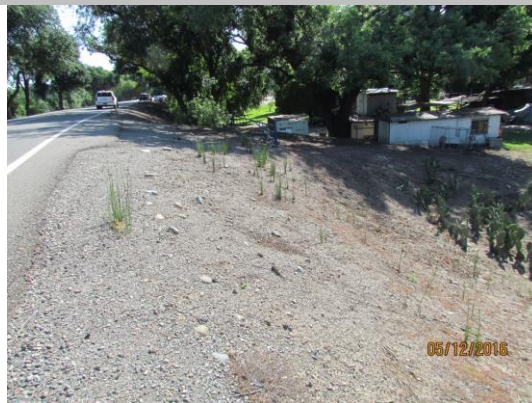
Photo 2 of 2 : FA_2018_RD0537_173_18_20180904_00015.jpg

LM Start	0.42	Rating **	M	Issue No.	18 (cont)
LM End	0.42	Issue Type +	En	Location *	LS

Perspective view of the landscaping on the landward side of the levee looking downstream. Spring 2016.

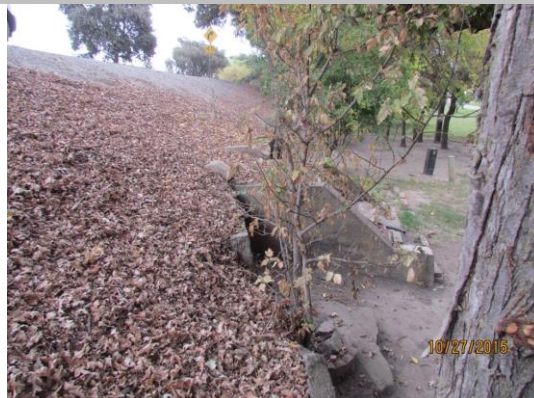
Photo 1 of 3 : FA_2018_RD0537_173_50_20180904_00043.jpg

View of the retaining wall at the levee toe on the landward side of the levee looking downstream. The wall is partially broken. Fall 2015.

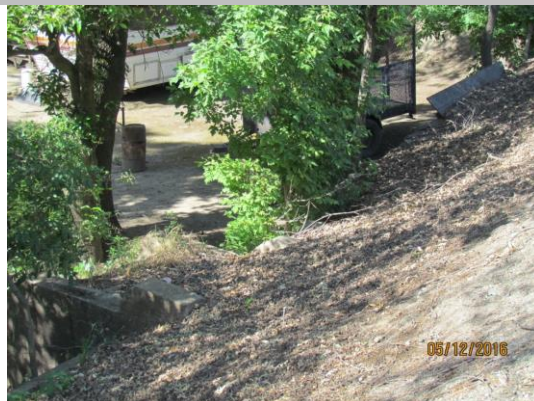
Photo 2 of 3 : FA_2018_RD0537_173_50_20180904_00044.jpg

LM Start	0.44	Rating **	M	Issue No.	50 (cont)
LM End	0.44	Issue Type +	En	Location *	LS

View of the retaining wall at the toe of the levee on the landward side. Spring 2016.

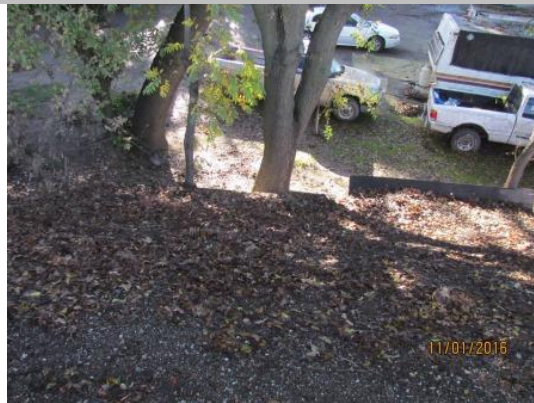
Photo 3 of 3 : FA_2018_RD0537_173_50_20180904_00045.jpg

Updated view of the site. Fall 2016.

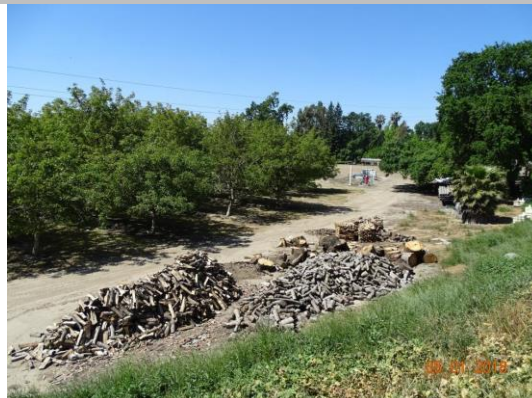
Photo 1 of 2 : FA_2018_RD0537_173_53_20180904_00048.jpg

Large piles of firewood at the landside toe. Spring 2018.

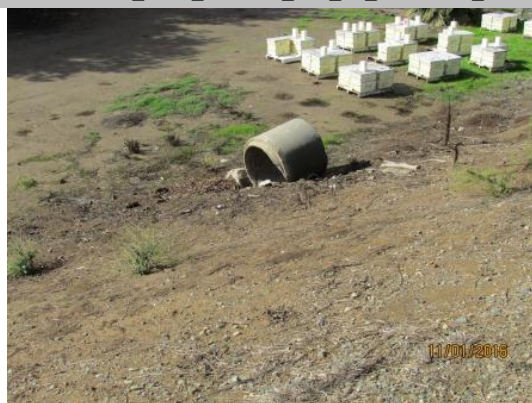
Photo 2 of 2 : FA_2018_RD0537_173_53_20180904_00049.jpg

Concrete ring at landside levee toe. Fall 2016.

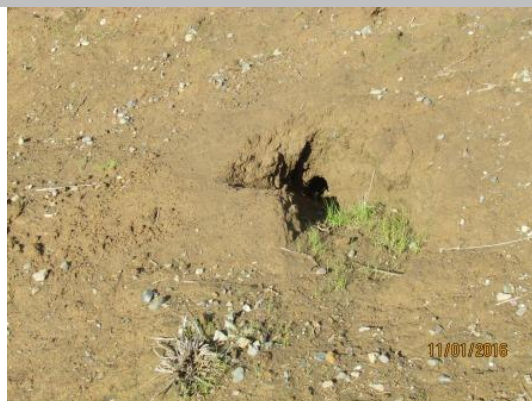
Photo 1 of 1 : FA_2018_RD0537_173_52_20180904_00047.jpg

LM Start	0.64	Rating **	M	Issue No.	52
LM End	0.64	Issue Type +	Ma	Location *	LS
Category	Earthen Levee			GPS Latitude/Longitude	
				Start	End
Item	Erosion / Bank Caving			38.647243 °	38.647243 °
				-121.574580 °	-121.574580 °
DWR ID	DWR_RD0537_01_f_2016_52				
Comment Code					
E2 : Schedule repair of erosion site prior to the next inspection.					
Inspector Comment

Rodent hole has erosion around less than 1ft deep. Fall 2016.

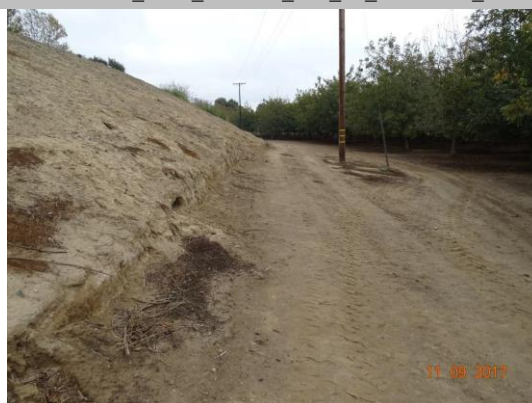
Photo 1 of 1 : FA_2018_RD0537_173_27_20180904_00018.jpg

View of tilling on the landside toe. Fall 2017.

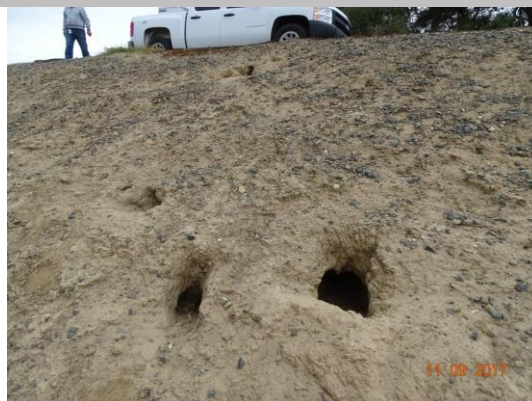
Photo 1 of 1 : FA_2018_RD0537_173_65_20180904_00057.jpg

View of holes on the landside slope. Fall 2017.

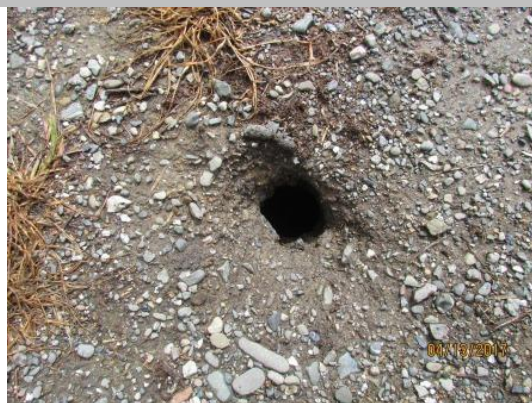
Photo 1 of 1 : FA_2018_RD0537_173_68_20180904_00059.jpg

Deep rodent hole on levee crown. Spring 2017.

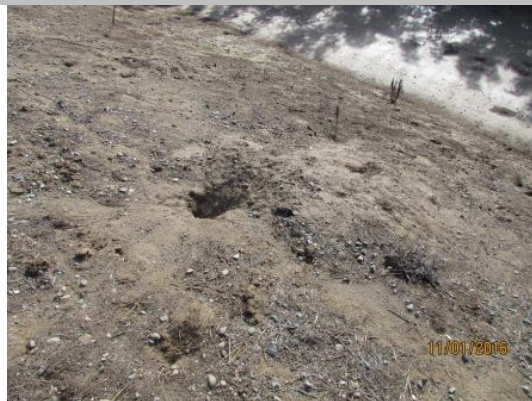
Photo 1 of 1 : FA_2018_RD0537_173_49_20180904_00042.jpg

Animal burrows on LS slope. Fall 2016.

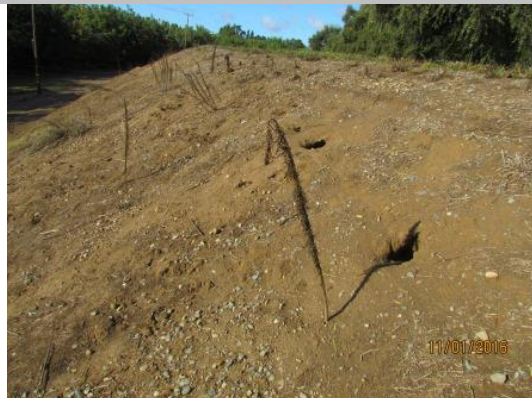
Photo 1 of 1 : FA_2018_RD0537_173_48_20180904_00041.jpg

Animal burrows on LS slope. Fall 2016.

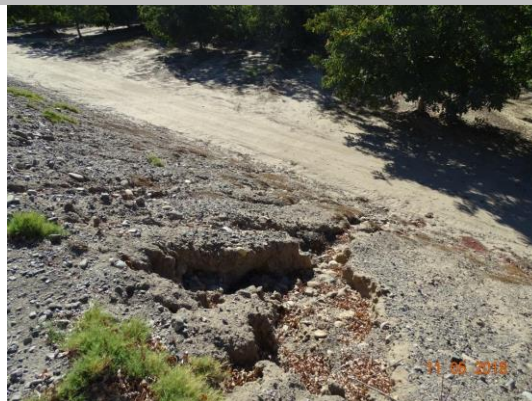
Photo 1 of 3 : FA_2018_RD0537_173_35_20181105_00091.jpg

LM Start	0.81	Rating **	U	Issue No.	35
LM End	0.81	Issue Type +	Ma	Location *	LS
Category	Earthen Levee			GPS Latitude/Longitude	
				Start	End
Item	Erosion / Bank Caving			38.647181 °	38.647181 °
				-121.571586 °	-121.571586 °
DWR ID	DWR_RD0537_01_f_2016_35				
Comment Code					
E2 : Schedule repair of erosion site prior to the next inspection.					
Inspector Comment					
Runoff erosion on landside slope. It has gotten deeper since the previous inspection.

View of erosion on the landside slope. Fall 2018.

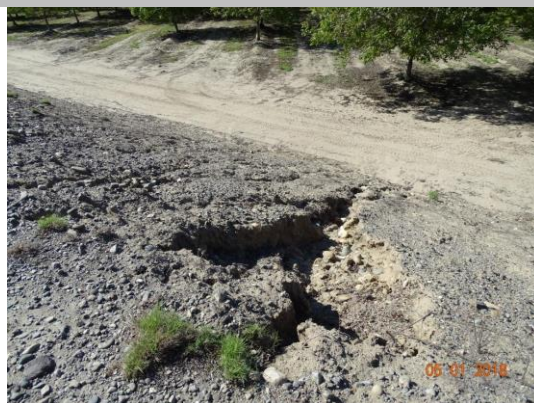
Photo 2 of 3 : FA_2018_RD0537_173_35_20180904_00024.jpg

LM Start	0.81	Rating **	U	Issue No.	35 (cont)	
LM End	0.81	Issue Type +	Ma	Location *	LS	
Category	Earthen Levee			GPS Latitude/Longitude		
				Start		End
Item	Erosion / Bank Caving			38.647181°	38.647181°	
				-121.571586°	-121.571586°	
DWR ID	DWR_RD0537_01_f_2016_35					
Comment Code						
E2 : Schedule repair of erosion site prior to the next inspection.						
Inspector Comment						
Runoff erosion on landside slope. It has gotten deeper since the previous inspection.

View of runoff erosion on the landside slope. Spring 2018.

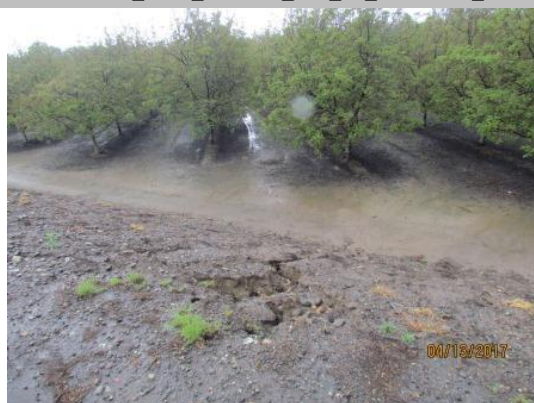
Photo 3 of 3 : FA_2018_RD0537_173_35_20180904_00025.jpg

View of runoff erosion on landside levee slope. Spring 2017.

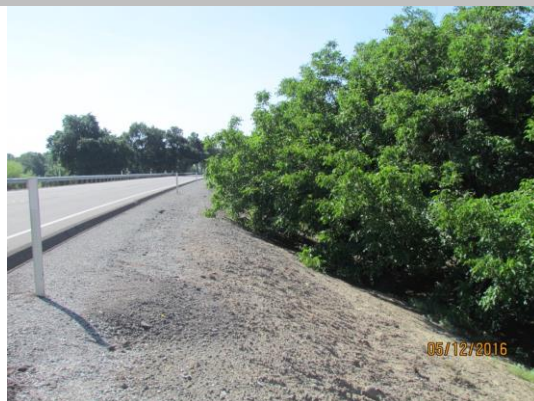
Photo 1 of 1 : FA_2018_RD0537_173_28_20180904_00019.jpg

View of the trees on the landward side of the levee looking downstream. Spring 2016.

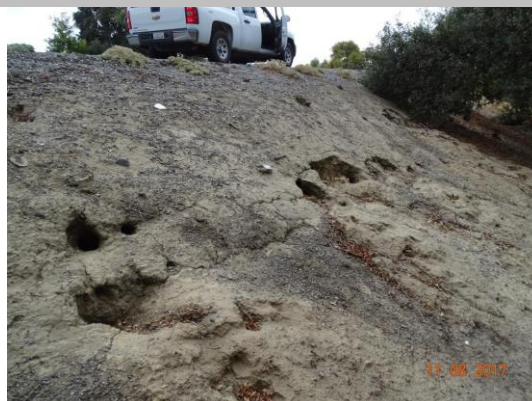
Photo 1 of 2 : FA_2018_RD0537_173_40_20180904_00032.jpg

Update view of rodent holes on the landside slope. Fall 2017.

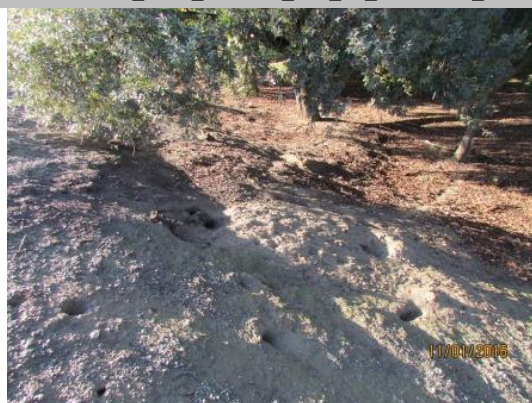
Photo 2 of 2 : FA_2018_RD0537_173_40_20180904_00033.jpg

View of rodent holes on LS slope. Fall 2016.

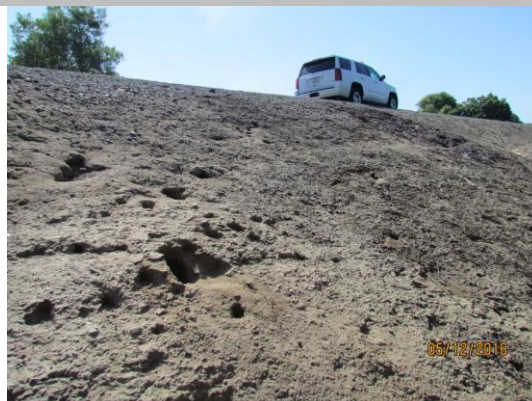
Photo 1 of 1 : FA_2018_RD0537_173_29_20180904_00020.jpg

View of the rodent holes on the landward side of the levee looking downstream. Spring 2016.

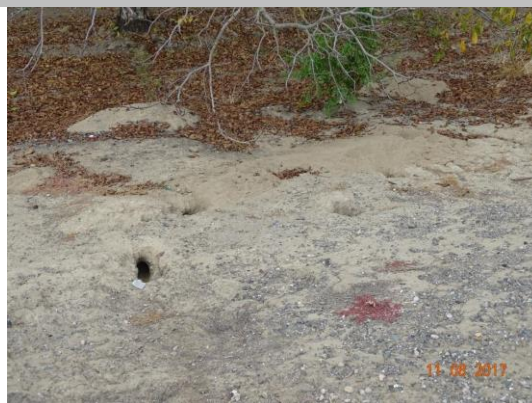
Photo 1 of 1 : FA_2018_RD0537_173_57_20180904_00053.jpg

View of rodent holes on the landside slope. Fall 2017.

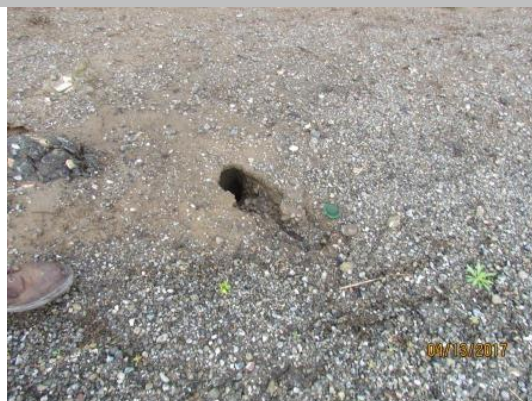
Photo 1 of 1 : FA_2018_RD0537_173_60_20180904_00055.jpg

Large burrow hole on landside levee slope. Spring 2017.

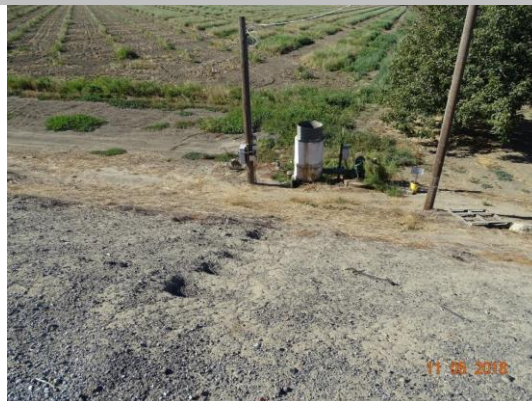
Photo 1 of 1 : FA_2018_RD0537_173_20_20181105_00092.jpg

View of stairs on the landside slope. Fall 2018.

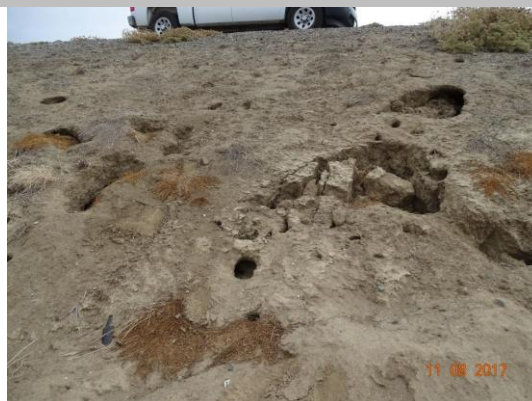
Photo 1 of 1 : FA_2018_RD0537_173_62_20180904_00056.jpg

View of rodent holes on the landside slope. Fall 2017.

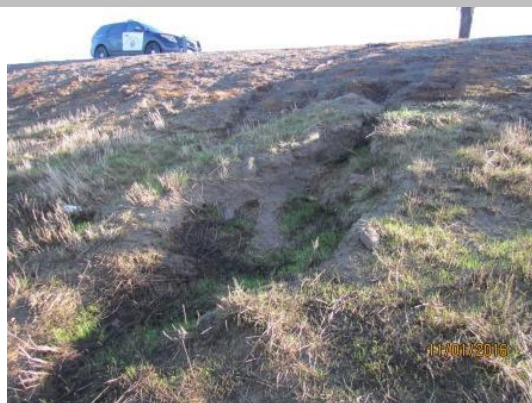
Photo 1 of 1 : FA_2018_RD0537_173_41_20180904_00034.jpg

LM Start	2.33	Rating **	M	Issue No.	41
LM End	2.33	Issue Type +	Ma	Location *	LS
Category	Earthen Levee			GPS Latitude/Longitude	
				Start	End
Item	Erosion / Bank Caving			38.627073 °	38.627073 °
				-121.563836 °	-121.563836 °
DWR ID	DWR_RD0537_01_f_2016_41				
Comment Code					
E2 : Schedule repair of erosion site prior to the next inspection.					
Inspector Comment

LS levee slope erosion. Fall 2016.

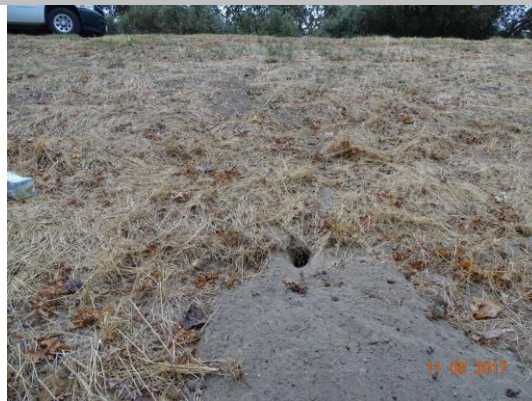
Photo 1 of 3 : FA_2018_RD0537_173_17_20180904_00011.jpg

Updated view of another rodent hole on the waterside slope. Fall 2017.

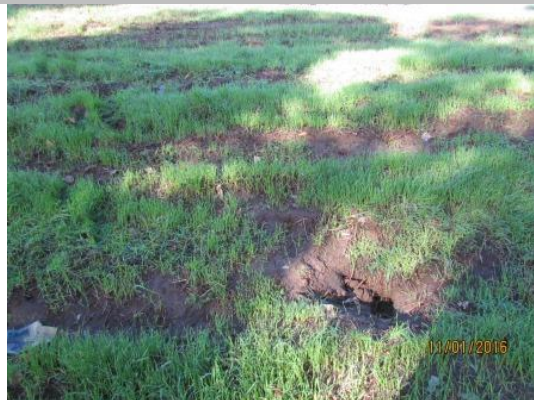
Photo 2 of 3 : FA_2018_RD0537_173_17_20180904_00012.jpg

View of the rodent hole on the waterward side of the levee. Fall 2016.

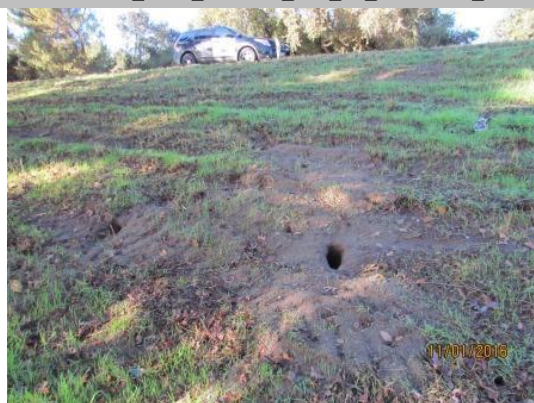
Photo 3 of 3 : FA_2018_RD0537_173_17_20180904_00013.jpg

View of the rodent hole on the waterward side of the levee. Fall 2016.

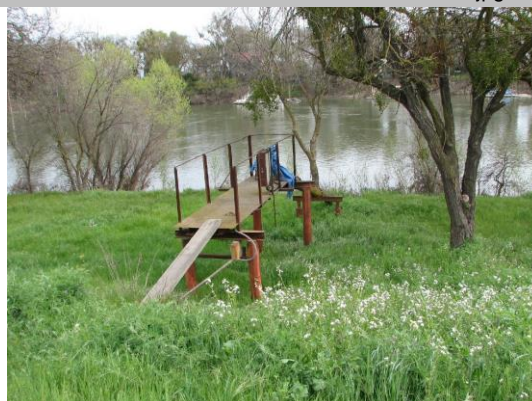
Photo 1 of 3 : UCIP_FA_2018_46035_17008.jpg

Comment Code						
Inspector Comment						
FS_ID:46035						
DS_ID:178						
EP_NO: N/A						
Repair Type: Non-Urgent						
Crossing Status: Found						
UCIP Comments: Wasted pipe and valve not visible due to vegetation.						
FIELD_STRUCT_DESC: 12-inch steel irrigation discharge pipe through the levee, 4.5 feet below the crown. Slant pump column on the riverbank. Timber walkway mounted on a pile structure across the waterside (WS) berm, not found. Siphon breaker in a corrugated metal pipe (CMP) riser on the landside (LS) slope. Concrete standpipe on the LS. 6-inch waste line down the WS bank with a gate valve. 2-inch electrical conduit through the levee. [Additional Reference(s): DWR Levee Log, 2004].						
FS Date: 3/18/2013

WS- overview of pump, pipe and steel structure structure.

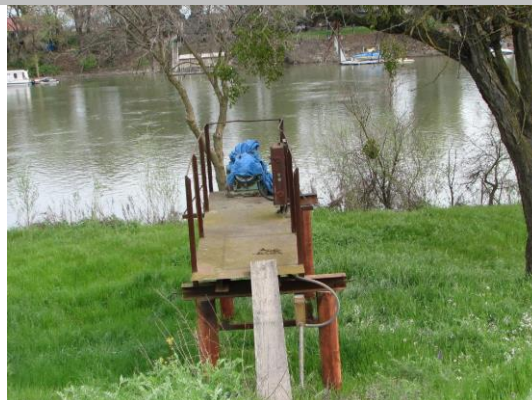
Photo 2 of 3 : UCIP_FA_2018_46035_17007.jpg

WS- closer view of pump, pipe and steel structure.

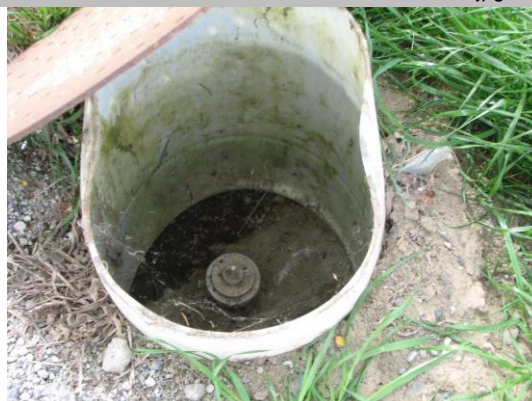
Photo 3 of 3 : UCIP_FA_2018_46035_17006.jpg

LS- siphon breaker in pvc pipe riser.

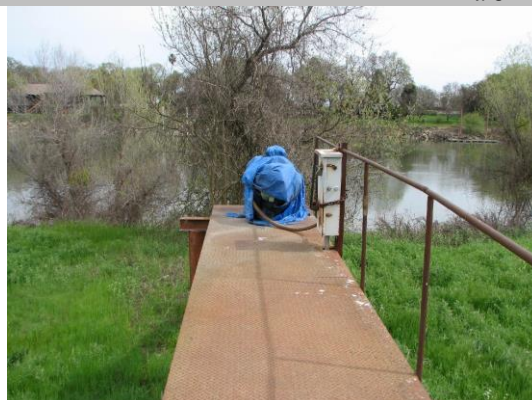
Photo 1 of 3 : UCIP_FA_2018_46037_17027.jpg

WS- overview of slanted pump on steel structure.

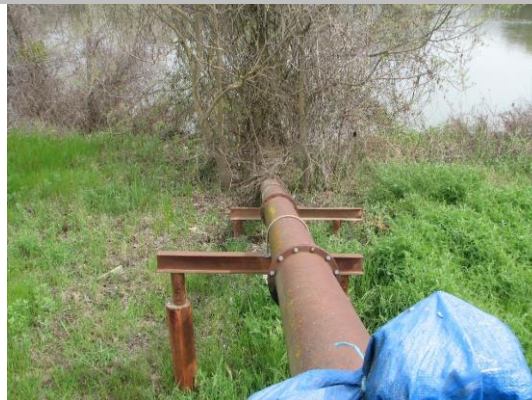
Photo 2 of 3 : UCIP_FA_2018_46037_17026.jpg

WS- slanted pump and pipe on steel structure.

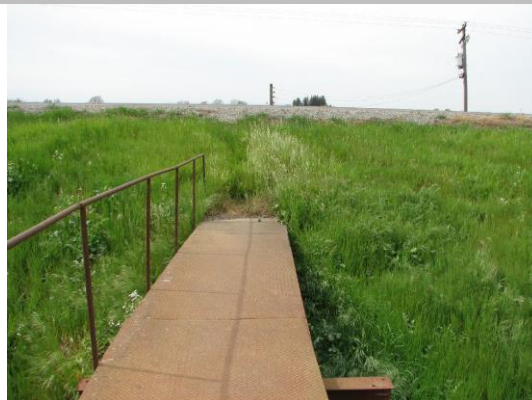
Photo 3 of 3 : UCIP_FA_2018_46037_17025.jpg

WS- steel walkway on pile structure.

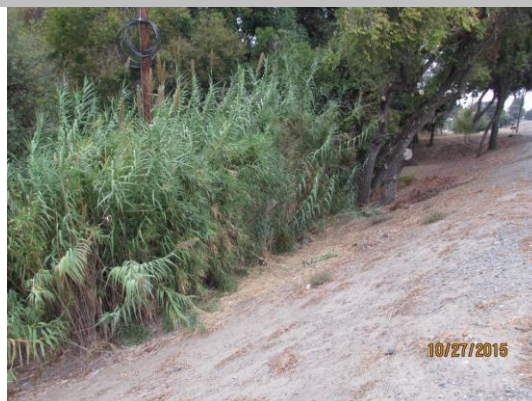
Photo 1 of 1 : FA_2018_RD0537_173_3_20180904_00001.jpg

View of the arundo at the levee toe on the landward side of the levee looking upstream. Fall 2015.

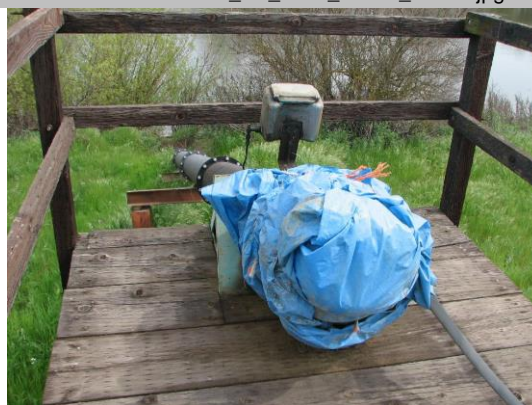
Photo 1 of 3 : UCIP_FA_2018_46806_17038.jpg

WS- slanted pipe and pump on timber structure.

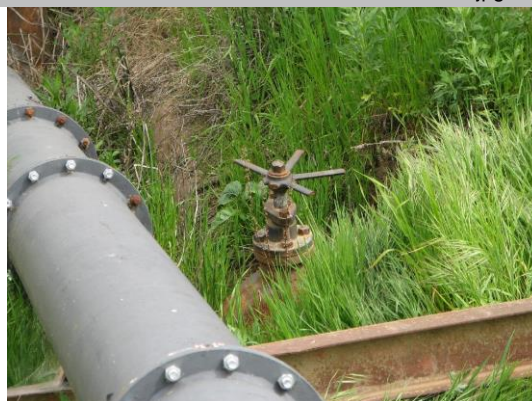
Photo 2 of 3 : UCIP_FA_2018_46806_17037.jpg

WS- main pipe and waste pipe with gate valve

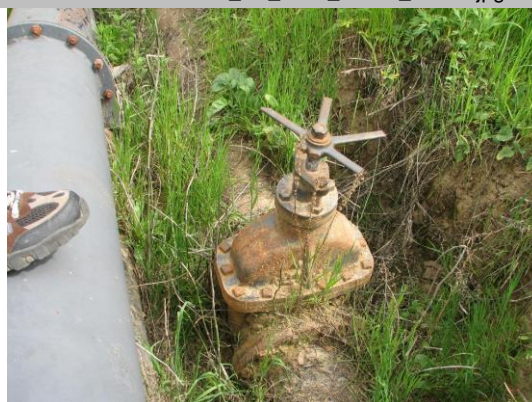
Photo 3 of 3 : UCIP_FA_2018_46806_17036.jpg

WS- main pipe and waste pipe with gate valve

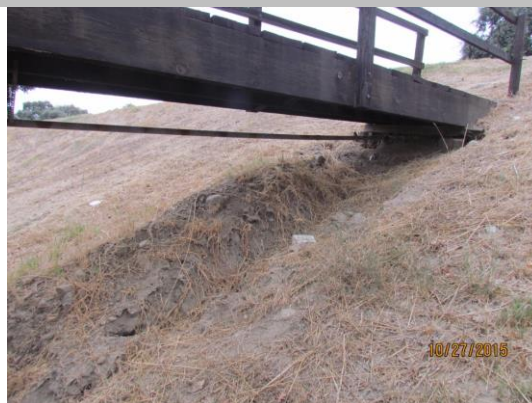
Photo 1 of 1 : FA_2018_RD0537_173_264_20180904_00063.jpg

There is erosion under the gangway on the waterward side of the levee looking downstream. Fall 2015.

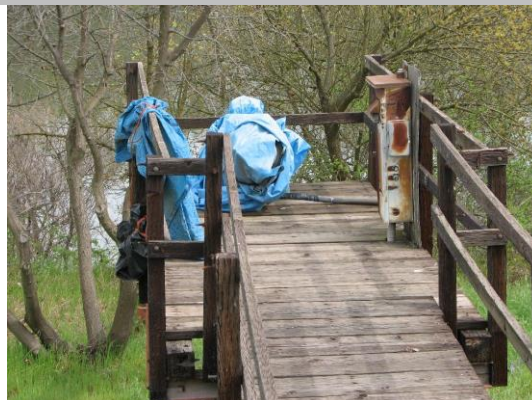
Photo 2 of 3 : UCIP_FA_2018_46041_17170.jpg

WS- covered slanted pump on timber platform.

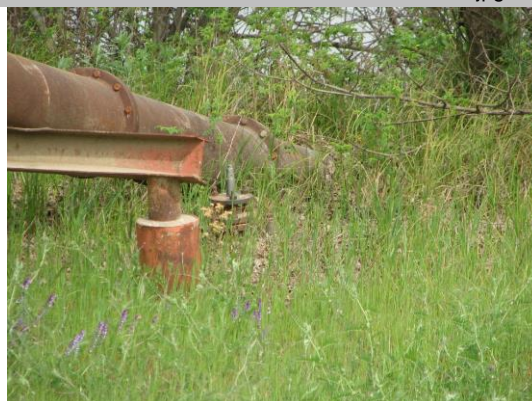
Photo 3 of 3 : UCIP_FA_2018_46041_17169.jpg

WS- slanted pipe and waste pipe gate valve

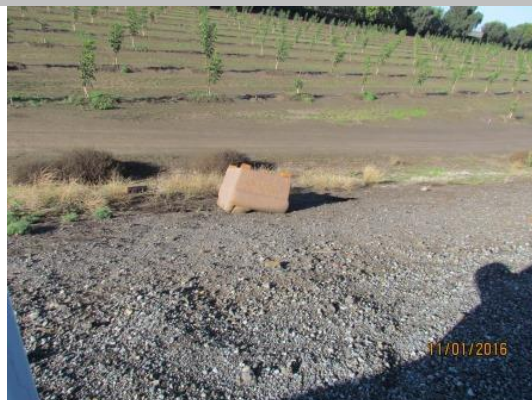
Photo 1 of 1 : FA_2018_RD0537_173_43_20180904_00035.jpg

Garbage on LS slope. Fall 2016.

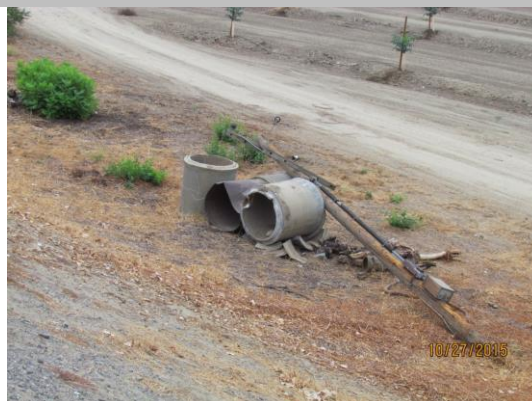
Photo 1 of 1 : FA_2018_RD0537_173_14_20180904_00006.jpg

View of concrete debris and a utility pole on the landward side of the levee. Fall 2015.

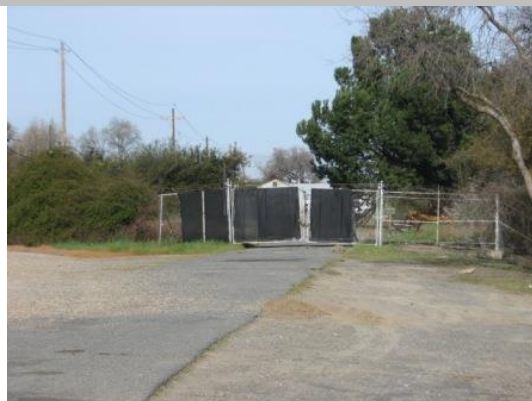
Photo 1 of 2 : FA_2018_RD0537_173_8_20180904_00004.jpg

Abandoned building and fence on the levee crown. Spring 2013

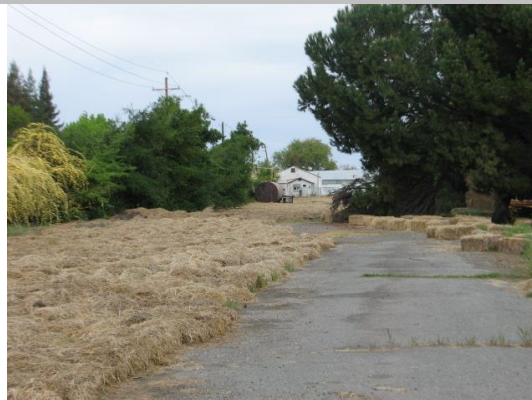
Photo 2 of 2 : FA_2018_RD0537_173_8_20180904_00005.jpg

Building and old equipment within the fenced compound. Spring 2014

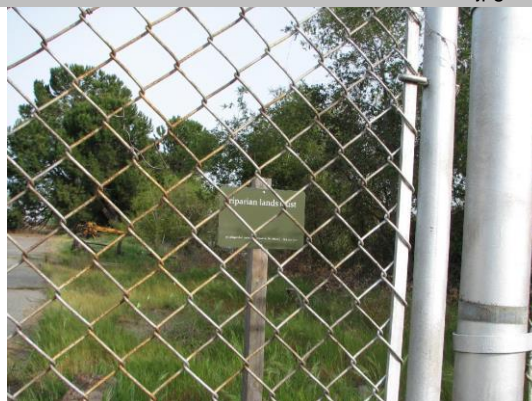
Photo 1 of 3 : UCIP_FA_2018_45026_17073.jpg

Riparian Lands Trust- no access through gate.

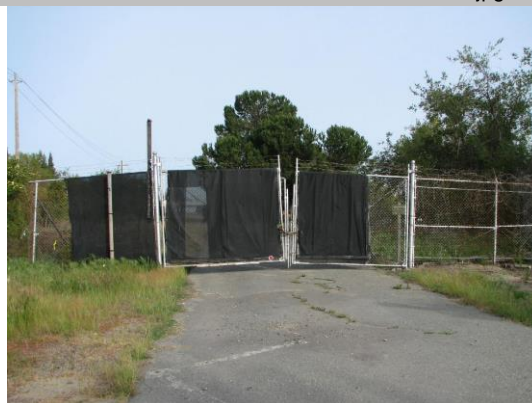
Photo 2 of 3 : UCIP_FA_2018_45026_17072.jpg

No access through gate. Area behind gated area along WS slope accessible.

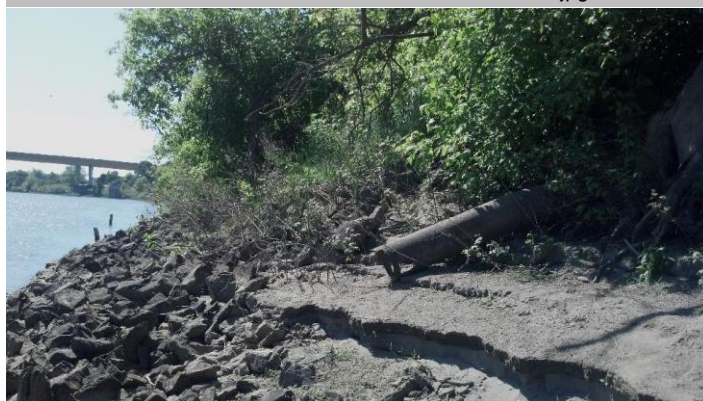
Photo 3 of 3 : UCIP_FA_2018_45026_74045.jpg

12" pipe along WS slope resting on possible remnant of pump house.

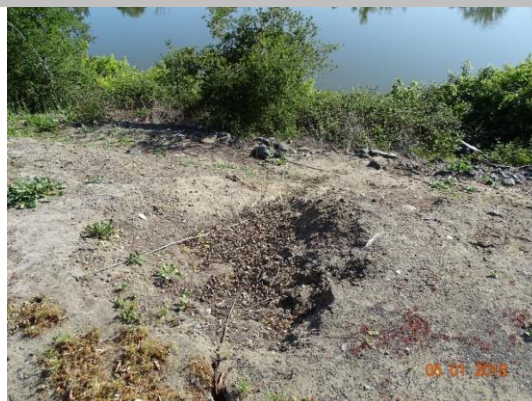
Photo 1 of 1 : FA_2018_RD0537_173_26_20180904_00017.jpg

View of runoff erosion on the waterside slope. Spring 2018.

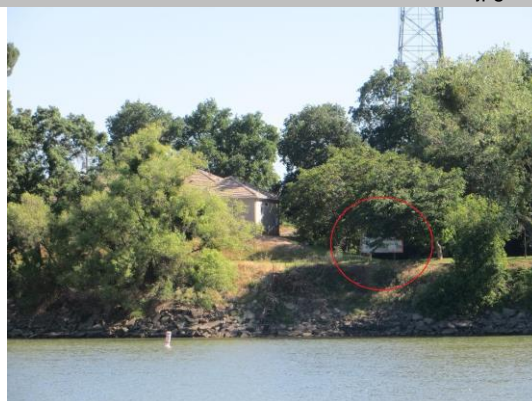
Photo 1 of 3 : UCIP_FA_2018_45024_74020.jpg

Red circle shows location of sign on opposite bank.

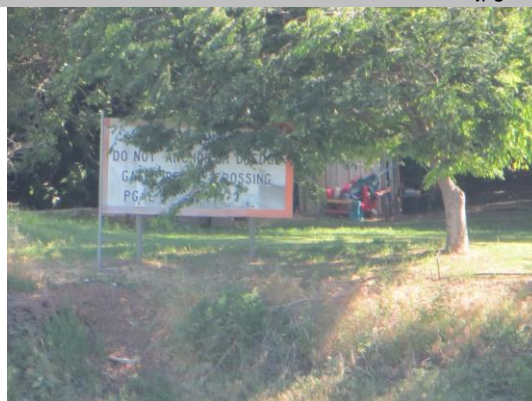
Photo 2 of 3 : UCIP_FA_2018_45024_74021.jpg

Closeup of PGE "Gas Pipeline Crossing" sign on opposite bank.

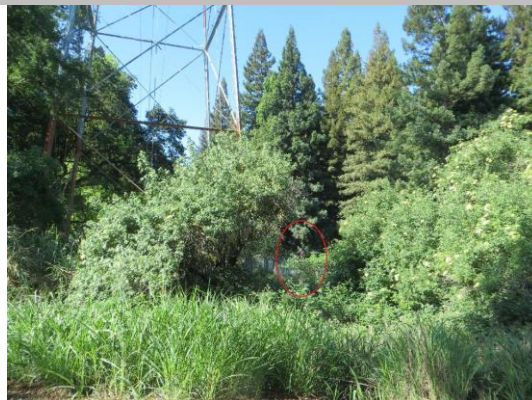
Photo 3 of 3 : UCIP_FA_2018_45024_74040.jpg

Marker off LS toe at base of tower at opposite side of RR tracks.

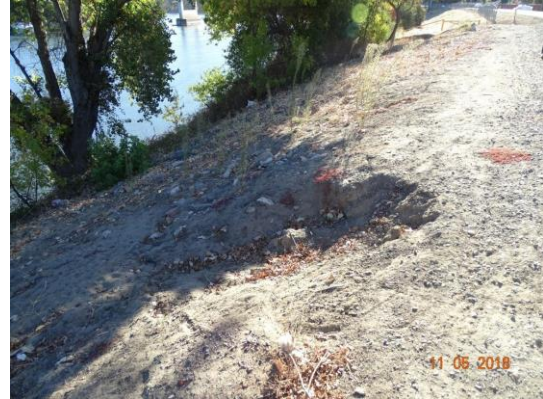
Photo 1 of 1 : FA_2018_RD0537_173_24_20181105_00089.jpg

View of erosion on waterside slope. Fall 2018.

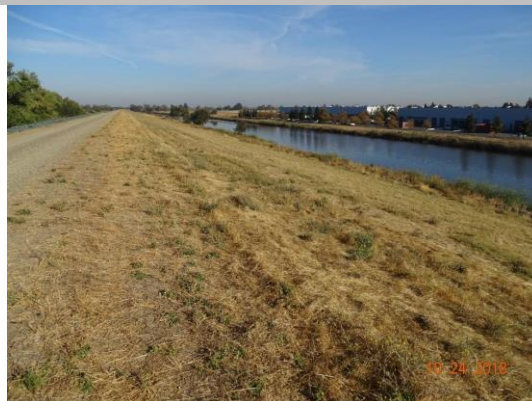
Photo 1 of 1 : FA_2018_RD0537_174_1_20181025_00002.jpg

View of grazed landside slope. Fall 2018.
